Tree Survey

St James's Square Bath

On behalf of
St James's Square Garden Ltd

January 2014

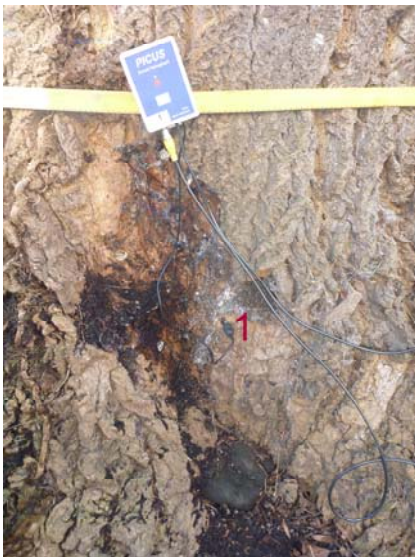
This tree has two small brackets of the decay fungus *Rigidoporus ulmarius* at ground level on the west (sensor 5) and north aspects (sensor 1). This decay causes a brown rot, resulting in degradation of the cellulose within the wood, whilst leaving the lignin largely intact. In an advanced state this can lead to the brittle fracture of the affected stem. The decay is usually confined to the central region of the buttress zone of the tree, (ref: Principles of Tree Hazard Assessment and Management. D. Lonsdale 1999).

Fig 1 - Fruiting body at sensor no.1

There is no indication that the fruiting bodies are putting on incremental growth, nor have any new fruiting bodies appeared.

The tulip tree is an important feature of the local area and should be retained as long as the benefit to the community, wildlife and landscape outweighs the risk posed to people and property. Based on the levels of decay identified in the tomograph survey, the tree may be retained, dependent upon regular visual inspection to monitor its condition. This should be undertaken annually and/or after periods of extreme weather. In addition, remedial work should be undertaken within two years in order to maintain the tree at a reduced scale.

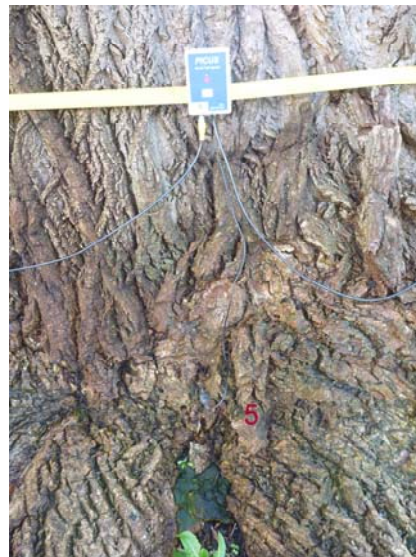
Fig 2 - Fruiting body at sensor no. 5

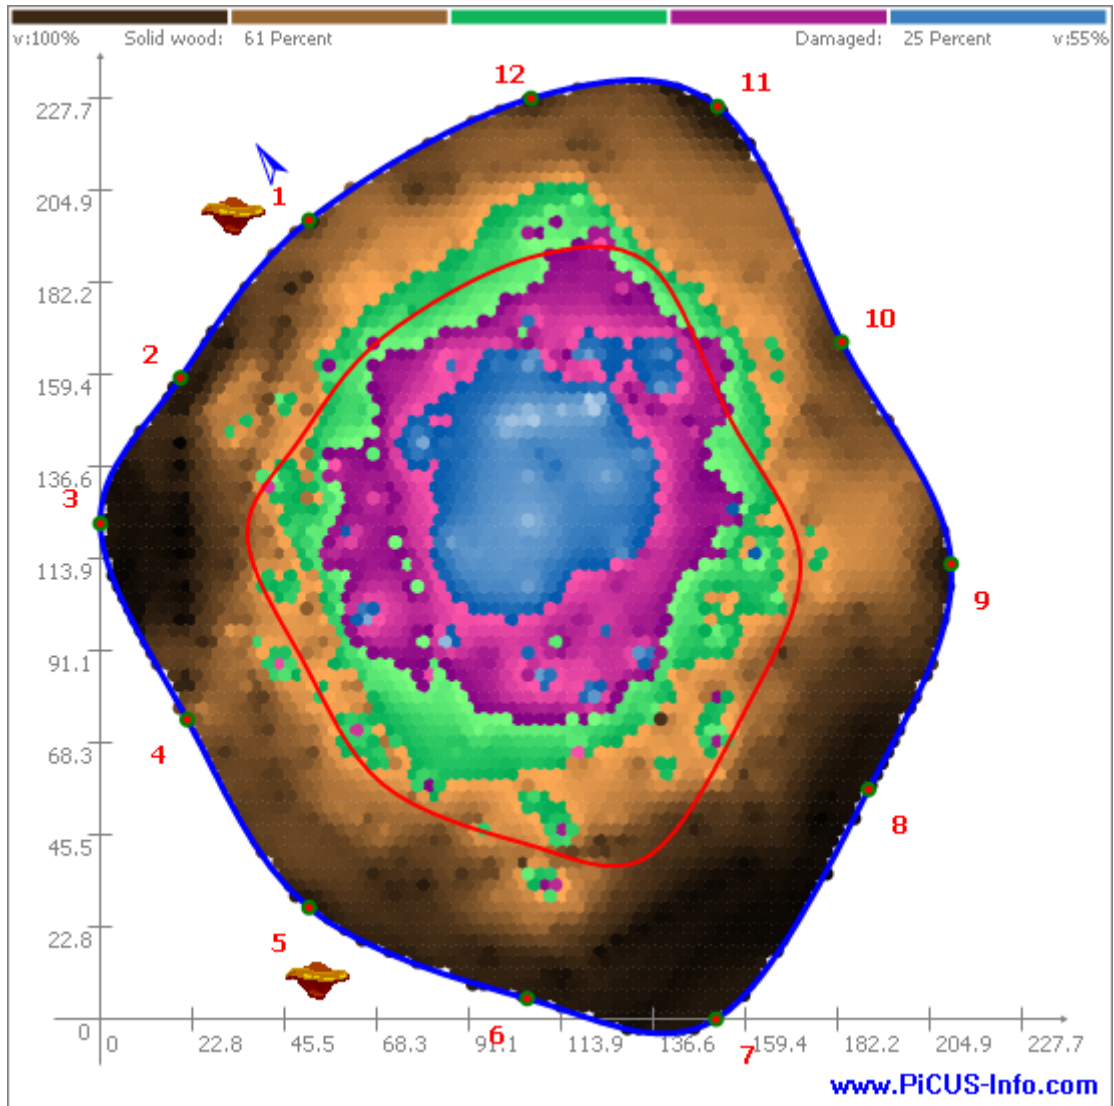
The results of the survey indicate that the decay levels remain broadly unchanged since the 2010. The 2014 readings actually show a 2% decrease in decay levels. This is due to slight variations in the location of sensors around the tree stem and is within acceptable limits.

The tomograph results indicate that there is still sufficient residual wall remaining at the point of measurement so as not to significantly reduce the strength of the stem. The previous crown reduction has also reduced leverage on the stem and this scale should be maintained by regular pruning (three to five years).

Species: Tulip tree *Liriodendron tulipifera*
Tag No. T1
Height: 26m
Stem Diameter at 1.5m: 178cm
Measurement level: 5cm
Survey Notes: *Rigidoporus ulmarius* fruiting bodies at stem base at sensor nos. 1 and 5

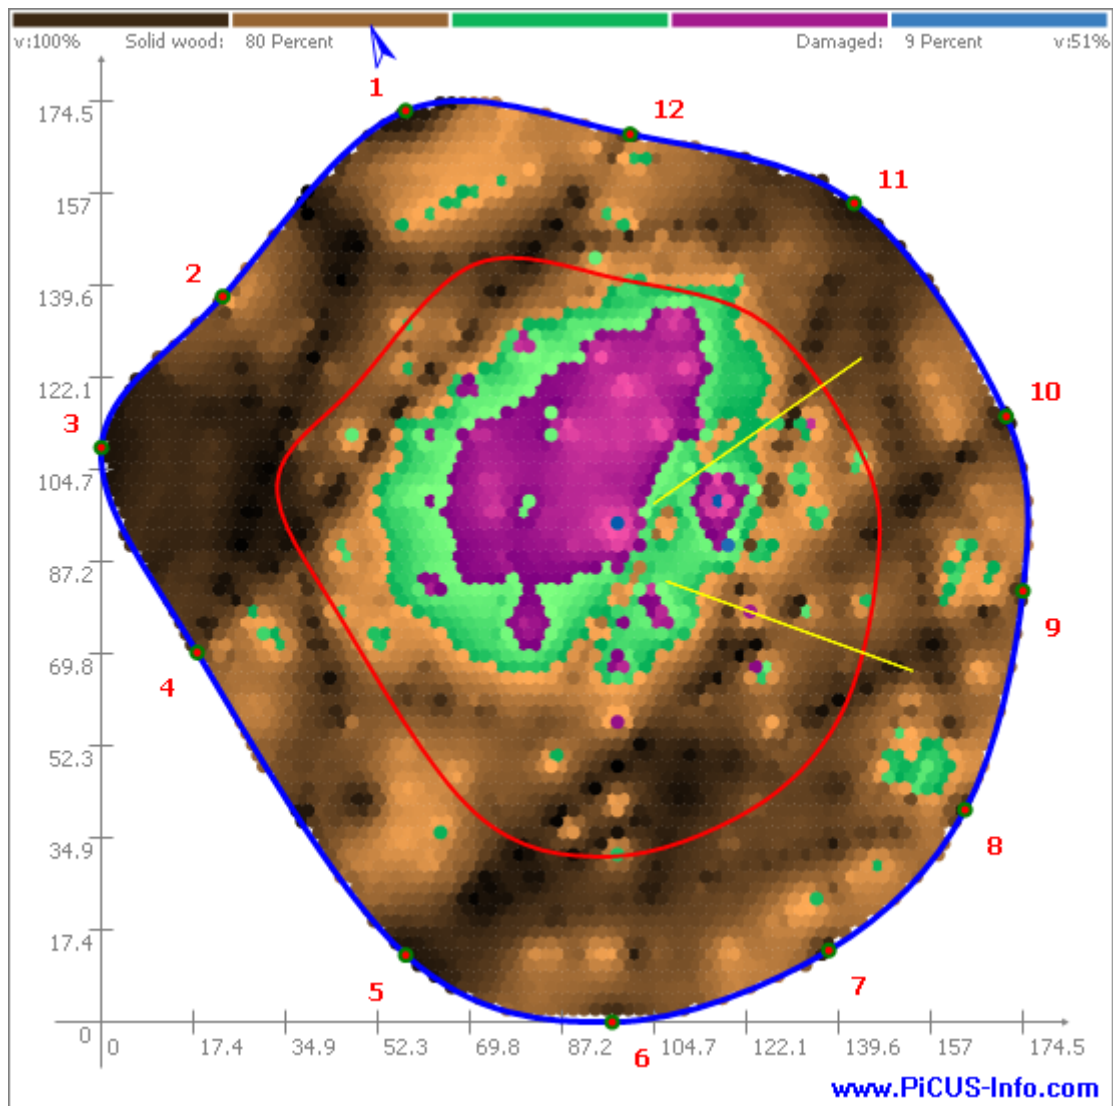
Species: Tulip tree *Liriodendron tulipifera*
Tag No. T1
Height: 26m
Stem Diameter at 1.5m: 178cm
Measurement level: 110cm
Survey Notes: *Rigidoporus ulmarius* fruiting bodies at stem base below sensor nos. 1 and 5

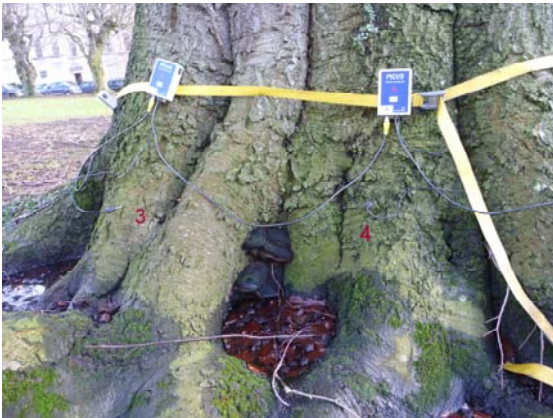
This tree has a small *Ganoderma* sp. fungal bracket at ground level on the west aspect between sensor nos. 3 and 4. This fungus causes a white rot of the heartwood whereby the lignin is selectively degraded, leaving the cellulose largely intact. When very advanced, this decay can lead to structural failure; however, the decayed wood can retain considerable tensile strength and trees can produce compensatory growth around the infected area and remain standing for many years.

Fig 3 - Fruiting body between sensor nos. 3 & 4

There is no indication that the fruiting bodies are putting on new incremental growth, nor have any new fruiting bodies appeared.

Due to the relatively small area of stem infected by this fungus, the tree may be retained, dependent on regular inspection to monitor its condition. This should be undertaken annually and/or after periods of extreme weather.

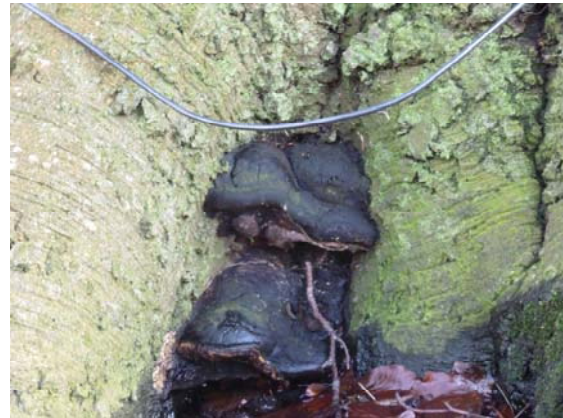
Fig 4- Close up of *Ganoderma* sp. fruiting body

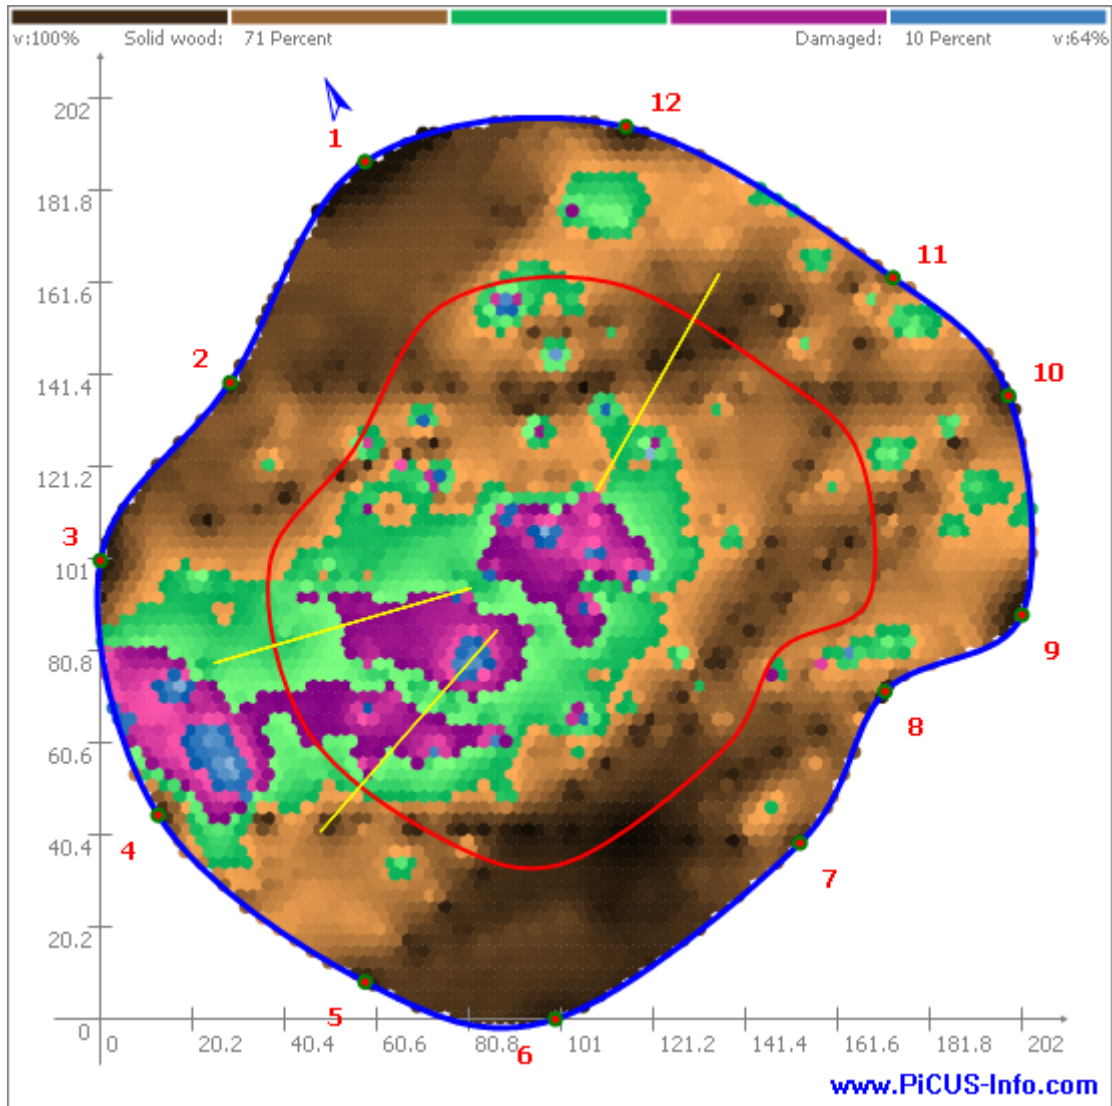
The results of the survey indicate that the decay levels remain broadly unchanged since the 2010, with 10% of the cross section highlighted as decayed (blue/pink). Please note the variation in decay pattern compared to 2010, due to variation in location of sensors between the two tomograms.

Species: Copper beech *Fagus sylvatica Purpurea*
Tag No. T7
Height: 26m
Stem Diameter at 1.5m: 148cm
Measurement level: 20cm
Survey Notes: Small *Ganoderma sp.* fruiting body at base on west aspect between sensor nos. 3 and 4
